# Portland Heritage Gaps Study

Glenelg Shire Council

Review and Recommendations Report

IS123700\_002 | V3

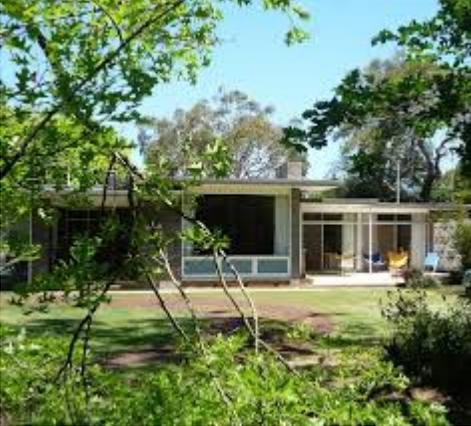
Item name and address	Current HO	Details	HERCON Assessment	Recommendations	Photographs
Residence, 27 Avonmore Avenue	None	Tag Walter designed 1960s home. Sympathetically restored and maintained. W.J.T. (Tag) Walter, Warrnambool's most important 20 <sup>th</sup> -century architect.  Priority Ranking: 1	Research Representative Aesthetic Creative / Technical Association (Individual)	Nominate for HO. Prepare significance assessment	2014

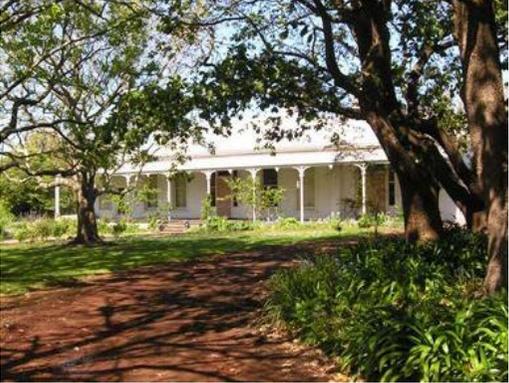
(Photo credit: Clinton Krause, 2014)
Residence, 28 Avonmore Avenue	None	Grand Victorian stone residence in garden setting on large property. Further research required. Priority Ranking: 1	Research Aesthetic Creative / Technical Association (Individual)?	Nominate for HO. Prepare significance assessment

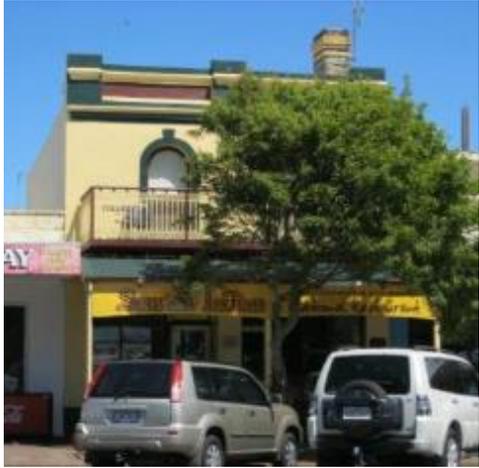
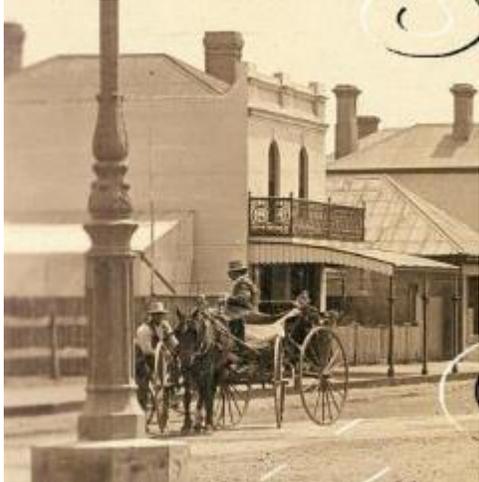
Item name and address	Current HO	Details	HERCON Assessment	Recommendations	Photographs
55 Bentinck St, Portland	Under HO165	<p>Good example of original two story double shop front. Brick upper façade. Upper storey balcony is original but has replacement railings. Verandah in original configuration with newer materials. Chimneys and roofline original. Internal not inspected.</p> <p>Priority Ranking: 2</p>	<p>Historical                      Representative                      Aesthetic                      Association (Individual?)</p>	<p>Nominate for HO.                      Prepare significance assessment</p>

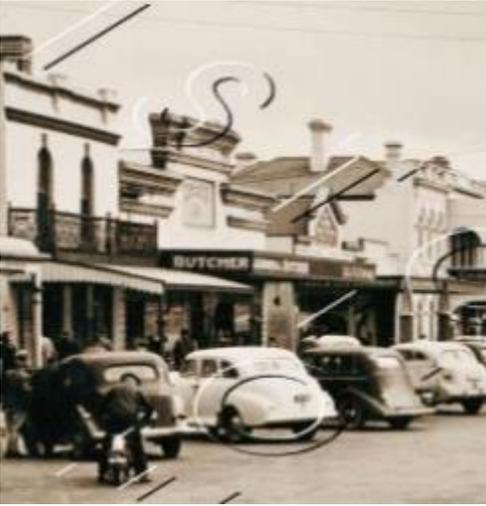
Item name and address	Current HO	Details	HERCON Assessment	Recommendations	Photographs
Murrells, Former Butcher, 57 Bentinck Street	Under HO165	<p>Murrells Butcher shop. Built 1934. Associated with Murrell Family. Intact example of 1930s shop front.</p> <p>Priority Ranking: 2</p>	<p>Historical Representative Aesthetic Association (Individual)</p>	<p>Nominate for HO. Prepare significance assessment</p>	<p>1950</p>

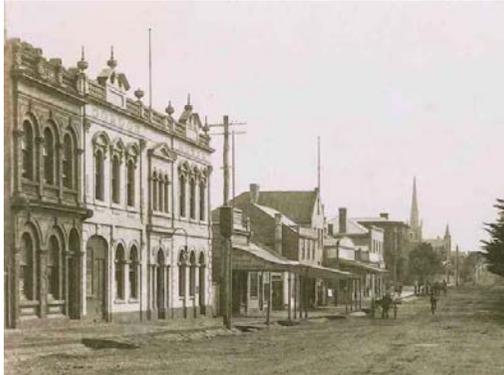
Item name and address	Current HO	Details	HERCON Assessment	Recommendations	Photographs
<p>Gordon Hotel , 63 Bentinck Street</p>	<p>Under HO165</p>	<p>Iconic in the streetscape of Bentinck Street. Was originally the Commercial Hotel.                      Portico added at a later date (c1920).                      Front of building is brick and stone (rendered) and rear buildings are timber.                      A site visit and internal inspection should be carried out in order to prepare a detailed significance assessment.</p> <p>Priority Ranking: 1</p>	<p>Historical                      Rarity                      Research                      Aesthetic                      Creative/ Technical                      Associative (Individual)</p>	<p>Nominate for HO.                      Prepare significance assessment</p>

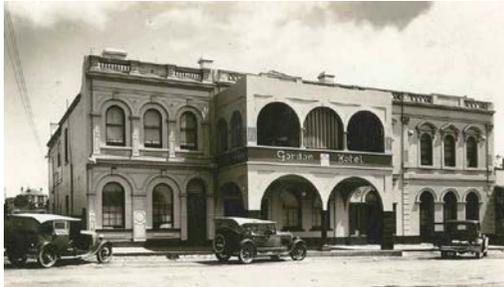
<p>Gordon Hotel post 1928 (Glenelg Shire Council)</p>

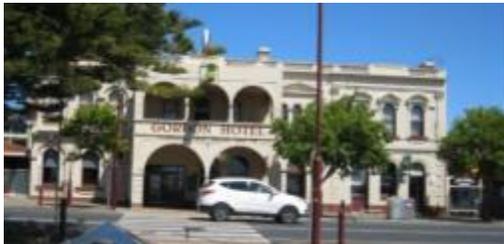
<p>Gordon Hotel 2015 (Photo: Rose Overberg 2015)</p>

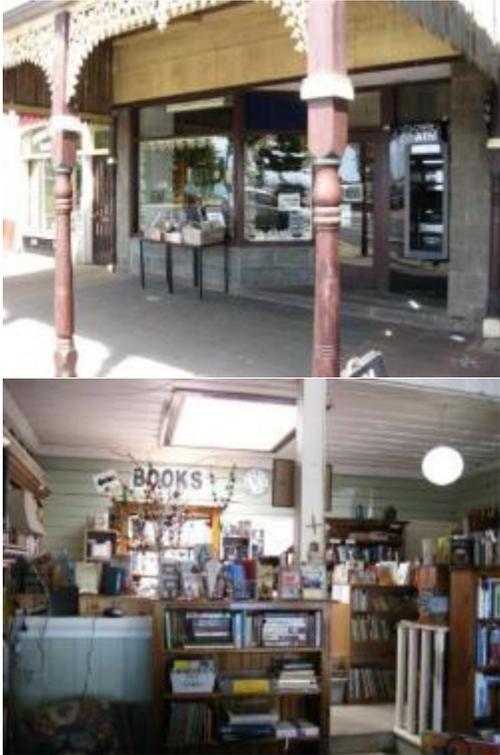
Item name and address	Current HO	Details	HERCON Assessment	Recommendations	Photographs
Shop, 67 Bentinck Street	Under HO165	<p>Stone front of shop and timber upper parapet (c1890s) placed in front of original timber shop front (1850s), which is still largely intact within. Original shop was draper or tailor. Shop includes laneway "infill" building which is an unusual building type.</p> <p>The "shop within a shop " concept is really interesting in this example.</p> <p>Priority Ranking: 1</p>	<p>Rarity Research Aesthetic Creative / Technical</p>	<p>Nominate for HO. Prepare significance assessment</p>

<p>Timber original shop front (green wall) (Photos: Rose Overberg 2015)</p>

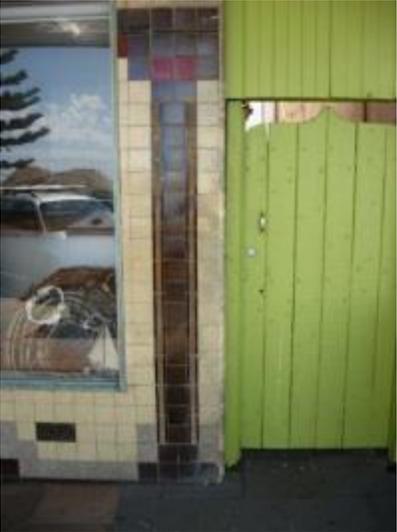
Item name and address	Current HO	Details	HERCON Assessment	Recommendations	Photographs
Shop, 83 Bentinck Street	Under HO165	<p>c1930s tiles at the front of shop represent columns. Repairs required to tiles on one side. Tiles postdate shop front. Top altered for balcony access. Upper façade not original.</p> <p>Priority Ranking: 2</p>	Historical Research	Nominate for HO. Prepare statement of significance

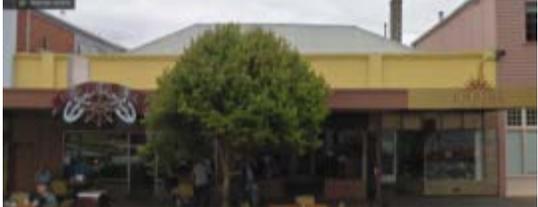
<p>(Photo: Rose Overberg 2015)</p>
Shops, 85-89Bentinck Street	Under HO165	<p>Very early shop (c1840-1850 ) and wall. Shop roof evident from street and old photo (c1886). 89 Bentinck St has interesting fire surround, simple in design and form and typical of an early development period. Material evidence of early foundations (beach stones at base topped with yellow brick)</p> <p>Priority Ranking: 1</p>	Historical Rarity Research	Nominate for HO. Prepare statement of significance

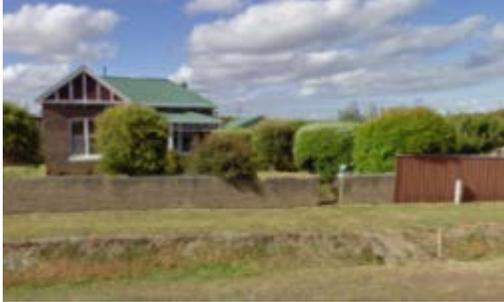
Residence, 42 Bridgewater Road	none	<p>Associated with the Parkers who owned Portland Brick Company. Built entirely of these bricks. Decorative timber on verandah. Mature orchard trees, well maintained. Prominent location.</p>	Historical Research Aesthetic Associative (Individual)	Nominate for HO. Prepare statement of significance

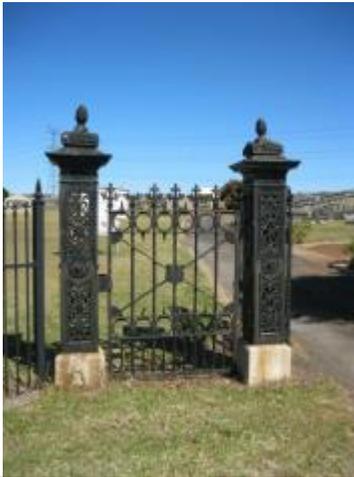
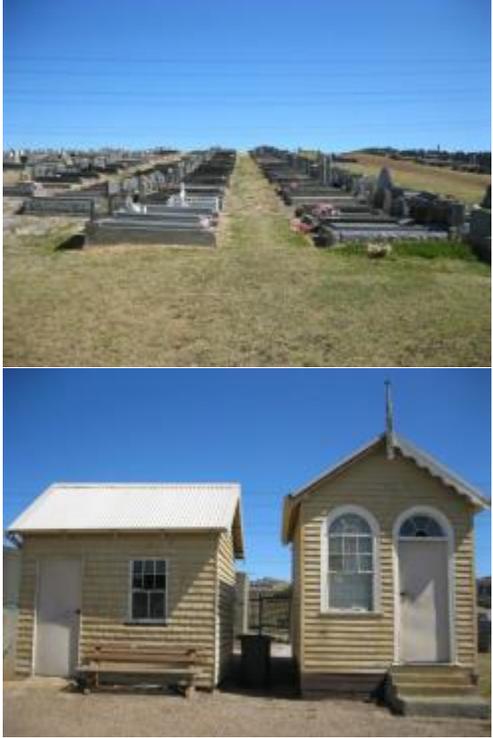
<p>(Photo: Google maps 2010)</p>
<p>Portland South Cemetery, 229 Cape Nelson Road</p>	<p>none</p>	<p>Large cemetery. Significant features include entrance gates, two cottages, layout, important associations, setting and dramatic nature of landscape.</p> <p>Priority Ranking: 1</p>	<p>Historical Rarity (buildings) Research Aesthetic Associative (Individual) Associative (Cultural)</p>	<p>Nominate for HO. Prepare statement of significance</p>

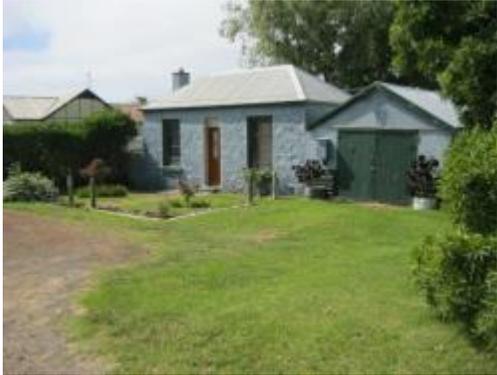
Item name and address	Current HO	Details	HERCON Assessment	Recommendations	Photographs
Residence, 33 Cashmore Road	none	<p>Small bluestone cottage and timber garage. Original and intact from external appearances. Excellent example of simple c1850s construction.</p> <p>Priority Ranking: 1</p>	<p>Historical Research Representative Aesthetic</p>	<p>Nominate for HO. Prepare statement of significance</p>

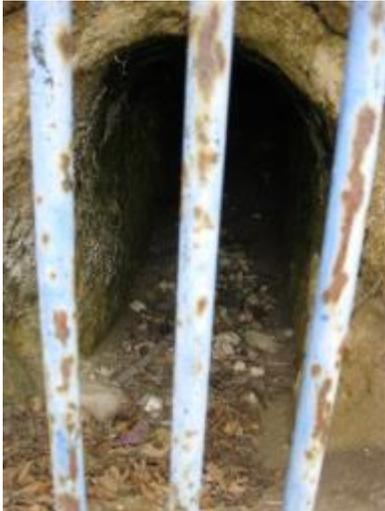
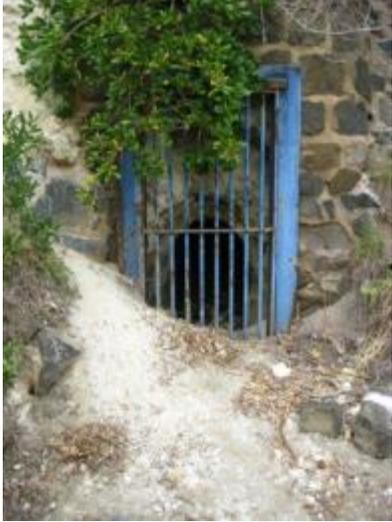
<p>(Photos: Rose Overberg 2015)</p>
Former Portland Gaol waste water tunnel, beneath Cliff Street	Within HO165	<p>Underground tunnel running from location of the former Portland Gaol to the foreshore. Very important infrastructure at early stage of Portland's development. Built in 1858 by John Burrow (Architect Surveyor for Portland). Original maps show location. Interesting to document the evolution of community myths around this feature as well (i.e. escape route for prisoners).</p> <p>Priority Ranking: 1</p>	<p>Historical Research Aesthetic Creative / technical Associative (Cultural) Associative (Individual)</p>	<p>Nominate for HO. Prepare statement of significance</p>

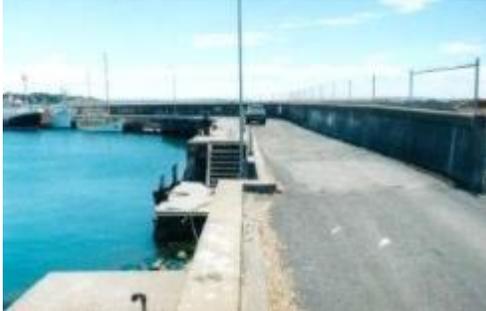
<p>(Photos: Rose Overberg 2015)</p>
Fisherman's Wharf	none	<p>The Fisherman's Wharf and Breakwater was constructed in the late 1880s, to a design by Sir John Coode, involving 'an early use of mass concrete in wharf construction'. The original timber viaduct at the base of the wharf has been lost but remnants of the spray wall may remain, as may some original handrails and decking, and two early timber cranes. Any remaining features will have significant heritage value.</p> <p>Site inspection will be required. National Trust will have research information as the item was nominated for inclusion on the VHR in 1990s.</p> <p>Priority Ranking: 1</p>	<p>Historical Rarity Research Representative Aesthetic Creative / technical Associative (Cultural)</p>	<p>Nominate for HO. Prepare statement of significance</p>

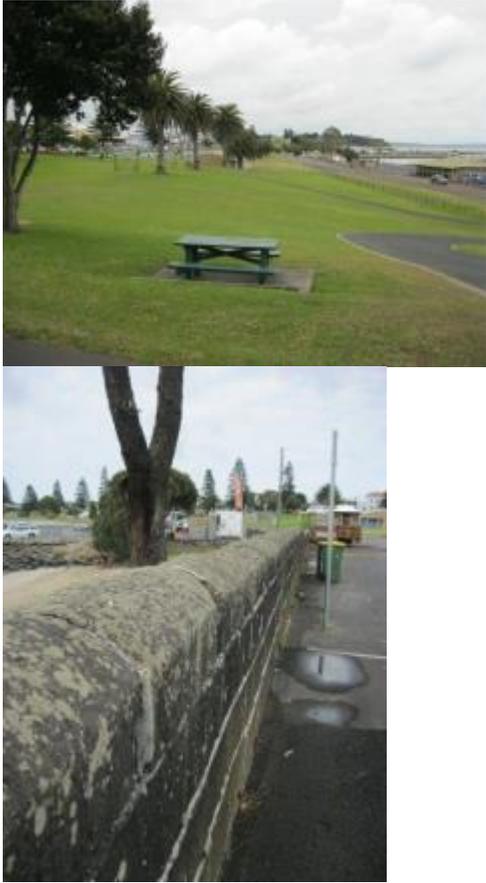
Item name and address	Current HO	Details	HERCON Assessment	Recommendations	Photographs
Portland Foreshore	none	<p>Significant tangible and intangible heritage places on the foreshore include:</p> <ul style="list-style-type: none"> <li>• Henty landing site – between Gawler and Julia Streets, location of first landing site by Edward Henty in the Thistle, resulting in establishment of first permanent settlement in Victoria.</li> <li>• Bluestone wall – remains of early walls associated with the development of the Port. Two phases evident in this wall. Associated with second jetty (1858) and the ocean pier (1902).</li> <li>• Foreshore infrastructure – includes foreshore access ramps associated with the former Portland Railway Station and painted mural on wall.</li> <li>• Locations of foreshore baths in the landscape and the cultural significance of these.</li> </ul> <p>Priority Ranking: 1</p>	<p>Historical Rarity Research Representative Aesthetic Creative / technical Associative (Cultural) Associative (Individual)</p>	<p>Nominate for HO Prepare statement of significance</p>

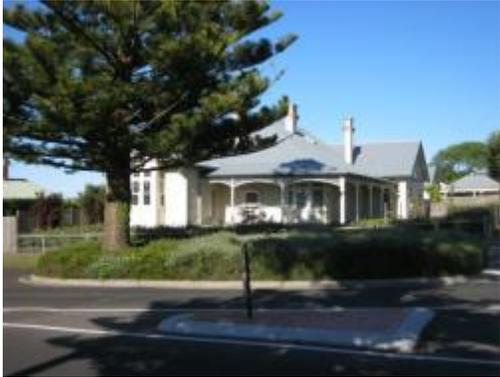
Item name and address	Current HO	Details	HERCON Assessment	Recommendations	Photographs
Residence, 31 Gawler Street	Within HO165	<p>Timber house, Edwardian Arts and Crafts c1920. Corner of Percy Street. Recently renovated. Leadlight windows.</p> <p>Priority Ranking: 2</p>	<p>Representative Aesthetic</p>	<p>Nominate for HO Prepare statement of significance</p>

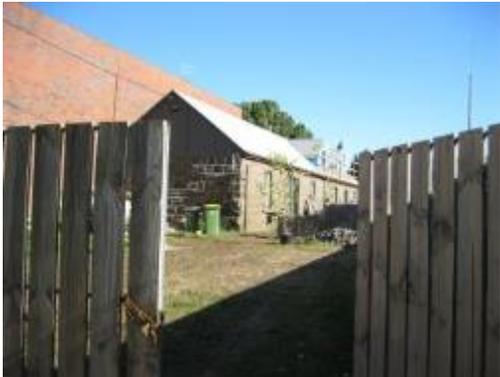
<p>(Photos: Rose Overberg 2015)</p>
Former stables or warehouse, 34 Gawler Street	Within HO165	<p>Bluestone warehouse or stables. Currently being renovated for use as residence. Refer planning permit information. National Trust file will contain additional information. Significance assessment needs to be updated.</p> <p>Priority Ranking: 2</p>	<p>Historical Research Representative Aesthetic</p>	<p>Nominate for HO Prepare statement of significance</p>	<p>December 2015</p>

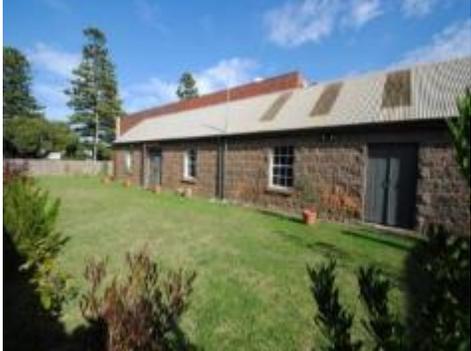
<p data-bbox="1592 740 1850 764">(Photo : Asset Real Estate)</p>
<p>Portland Powerhouse, 23 Glenelg Street</p>	<p>Within HO165</p>	<p>Further research need to confirm whether the structure is in its original. Located adjacent to Fawthrop Lagoon. Research history and significance.</p> <p>Priority Ranking: 1</p>	<p>Historical Rarity Research Representative Creative / technical Associative (Cultural)</p>	<p>Nominate for HO Prepare statement of significance</p>

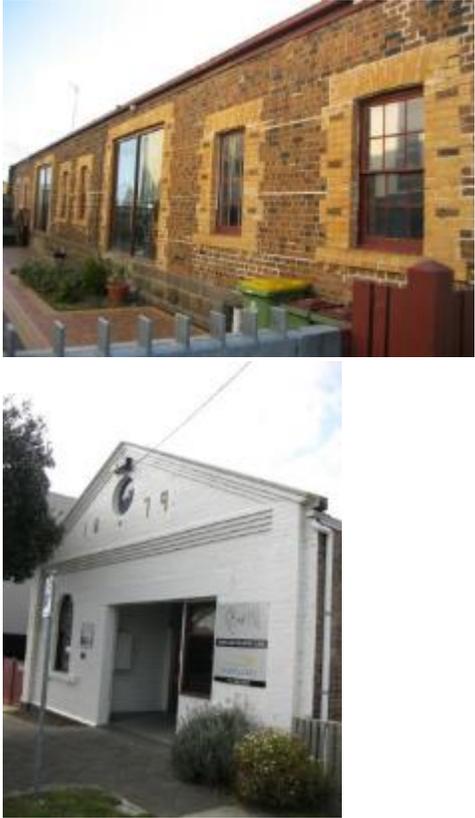
Item name and address	Current HO	Details	HERCON Assessment	Recommendations	Photographs
Warehouse, 3 Henty Street	Within HO165	<p>Polychrome brick warehouse, with interesting brick date motif on parapet. C1879. Front entrance has been altered.</p> <p>Priority Ranking: 1</p>	<p>Historical Rarity Research Representative Creative / technical</p>	<p>Nominate for HO Prepare statement of significance</p>

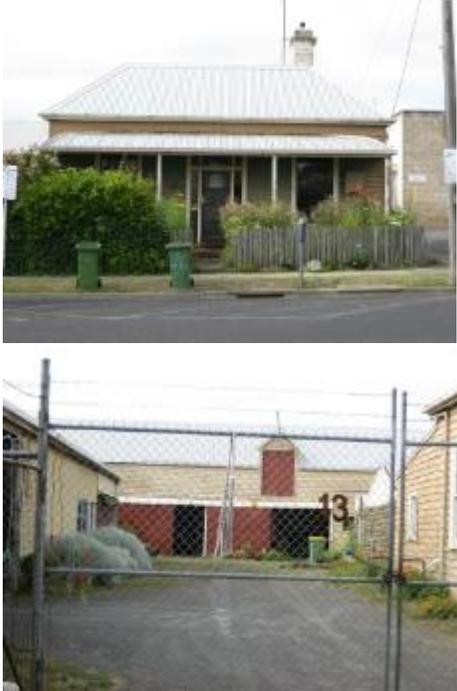
Item name and address	Current HO	Details	HERCON Assessment	Recommendations	Photographs
House stables and outbuildings, 13 Henty Street	Within HO165	<p>House is timber, double fronted. Stables, timber iron-clad at rear of property were built in 1896. Assess interior o stables and include on heritage listing. Fabric demonstrates original use. Associated with Thomas Hickey, Stable keeper, who owned 13 Henty Street.</p> <p>Priority Ranking: 1</p>	<p>Historical Rarity Research Representative Creative / technical</p>	<p>Nominate for HO Prepare statement of significance</p>

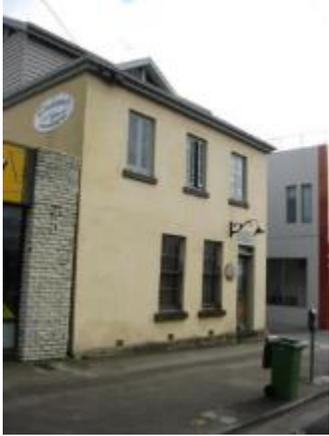
Item name and address	Current HO	Details	HERCON Assessment	Recommendations	Photographs
Residence, 14 Henty Street	Within HO165	<p>Double storey residence, brick and bluestone. Third floor is renovated. Built for William Corney (1816-1898). It was built in the 1850s (?). Has been a wool warehouse and shop.</p> <p>Priority Ranking: 2</p>	<p>Historical Creative / technical Associative (Individual)</p>	<p>Nominate for HO Prepare statement of significance</p>

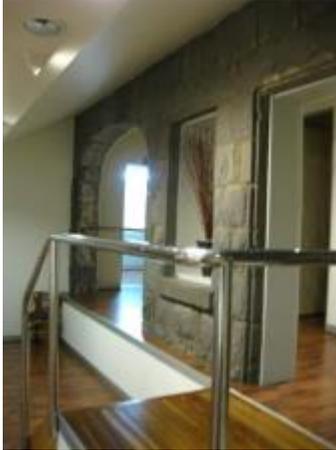
<p>(Photo: Rose Overberg 2015)</p>
Bluestone wall, 19 Henty Street	Within HO165	<p>Large bluestone wall and arches within building (Jedore Beauty) at this address. Research original building use, function and owner.</p> <p>Priority Ranking: 2</p>	<p>Historical Rarity Research Creative / technical Aesthetic</p>	<p>Nominate for HO Prepare statement of significance</p>

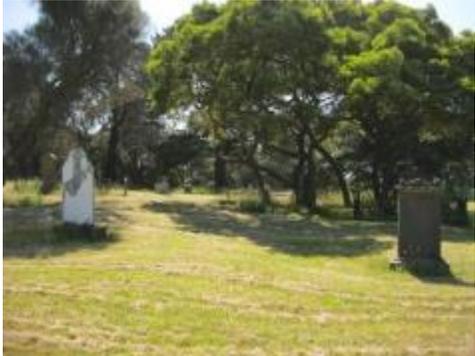
Item name and address	Current HO	Details	HERCON Assessment	Recommendations	Photographs
Portland North Cemetery, 632 Henty Highway	none	<p>Significant heritage place for location, landscape, trees, associations, graves, cultural / social and age of site.</p> <p>Priority Ranking: 1</p>	<p>Historical Research Aesthetic Associative (Individual) Associative (Cultural)</p>	<p>Nominate for HO Prepare statement of significance</p>

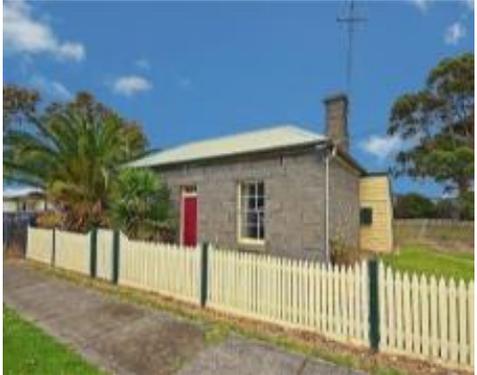
Item name and address	Current HO	Details	HERCON Assessment	Recommendations	Photographs
Residence, 125 Hurd Street	none	Bluestone cottage. Built for W Robb.  Priority Ranking: 1	Historical Representative Aesthetic Associative (Individual)	Nominate for HO Prepare statement of significance

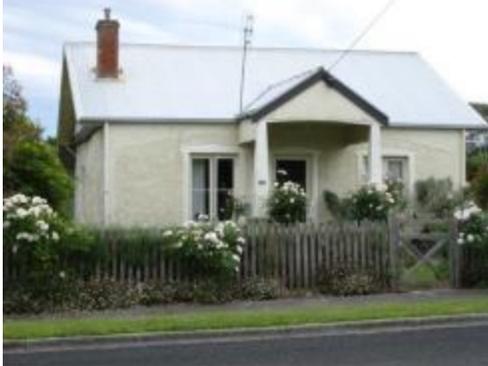
<p data-bbox="1592 767 1980 791">(Photo credit: homehound.com.au, 2015)</p>
Residence, Former Barleycorn Inn, 221 Hurd Street	none	Bluestone house, former Barleycorn Inn. C1850s.  Priority Ranking: 1	Historical Rarity Representative Aesthetic Associative (Individual)	Nominate for HO Prepare statement of significance

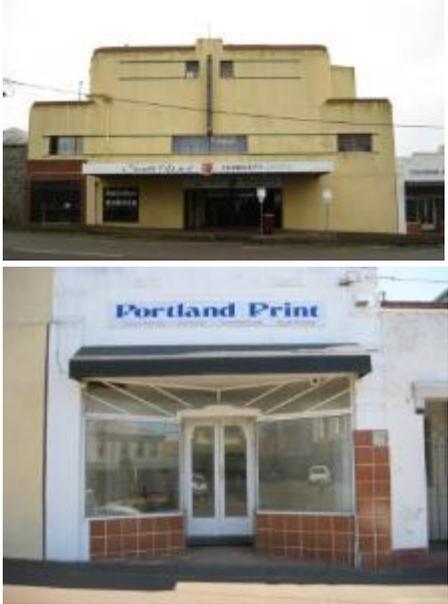
Item name and address	Current HO	Details	HERCON Assessment	Recommendations	Photographs
Star Cinema and adjacent Shop	Within HO165	<p>Star Cinema is a unique building in Portland, and represents one of a few Art Deco public buildings within the Shire.</p> <p>Interior is typical of 1930s Art Deco. The Star Cinema opened in the 1930's, with 991 seats located in orchestra and balcony levels. Small shop to the east has original and interesting features.</p> <p>Priority Ranking: 1</p>	<p>Historical Rarity Research Aesthetic Associative (cultural)</p>	<p>Nominate for HO Prepare statement of significance</p>

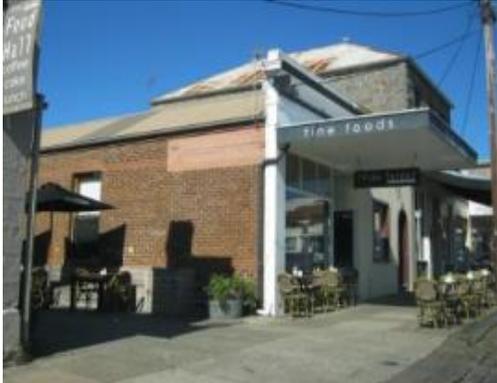
<p>(Photo : Rose Overberg 2015)</p>
Shop, 5 Julia Street and bluestone buildings at rear of 3 and 5 Julia	Within HO165	<p>Currently Lido Larder Café. Polychrome brick on side elevation.</p> <p>Bluestone store building at rear possibly older and need assessment</p> <p>Priority Ranking: 2</p>	<p>Historical Research Aesthetic</p>	<p>Nominate for HO Prepare statement of significance</p>

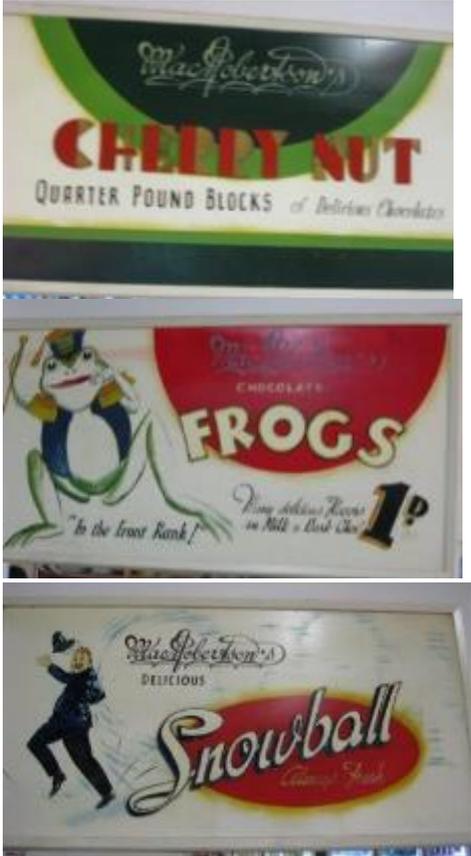
Item name and address	Current HO	Details	HERCON Assessment	Recommendations	Photographs
<p>MacRobertson's advertising in shop, 47 Julia Street</p>	<p>Within HO165</p>	<p>The shop has three panels of advertising (pre-decimal ) for MacRobertson's chocolates. HO listing to include this fabric only.</p> <p>Priority Ranking: 1</p>	<p>Rarity Research Aesthetic Association (Individual)</p>	<p>Nominate for HO Prepare statement of significance</p>

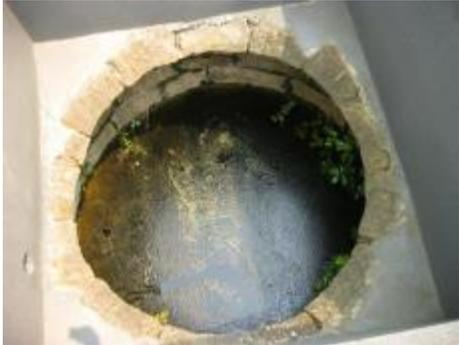
Item name and address	Current HO	Details	HERCON Assessment	Recommendations	Photographs
Well, 66 Julia Street	Within HO165	<p>Location of well associated with Mary MacKillop's family and early days of Portland. Located at the northern end of 66 Julia Street at the rear of Quest Apartments. HO should just be location of well and a reasonable curtilage.</p> <p>Priority Ranking: 1</p>	<p>Historical Rarity Research Creative / technical Associative (Individual)</p>	<p>Nominate for HO Prepare statement of significance</p>

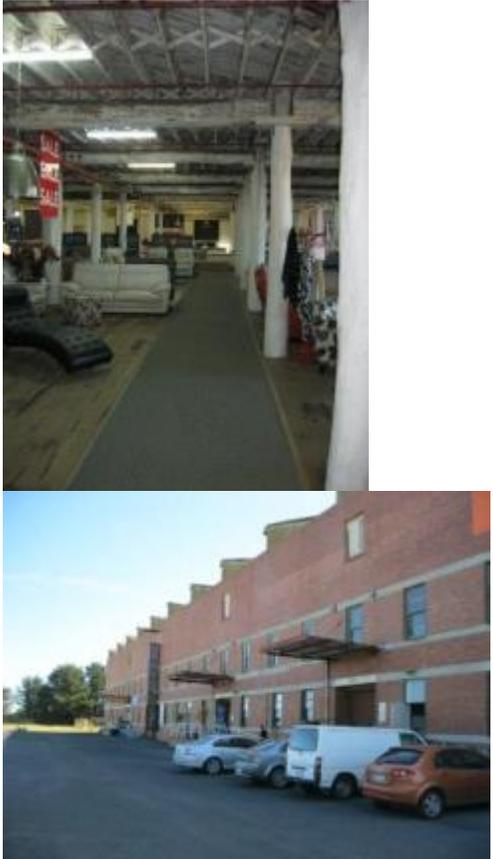
Item name and address	Current HO	Details	HERCON Assessment	Recommendations	Photographs
<p>Brick Wool store, 109 Learmonth Street</p>	<p>none</p>	<p>c1946. Massive timber pole and beam construction clad in red brick walls. Representative of post-war industrial development in Portland Associated with wool selling centre at 120 Learmonth (dates to 1960s)  Priority Ranking: 1</p>	<p>Historical Rarity Research Aesthetic</p>	<p>Nominate for HO Prepare statement of significance</p>

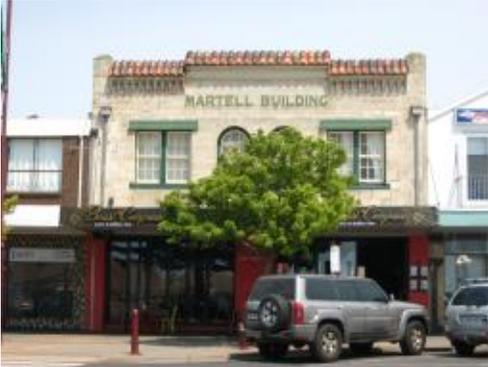
Item name and address	Current HO	Details	HERCON Assessment	Recommendations	Photographs
Martell Building, 81 Bentinck Street	Under HO165	<p>Large stone parapet, which has had some alterations. Large bluestone wall on northern boundary runs through restaurant and into rear yard. Research age and original function.</p> <p>Priority Ranking: 2</p>	Aesthetic Historical	Nominate for HO Prepare statement of significance

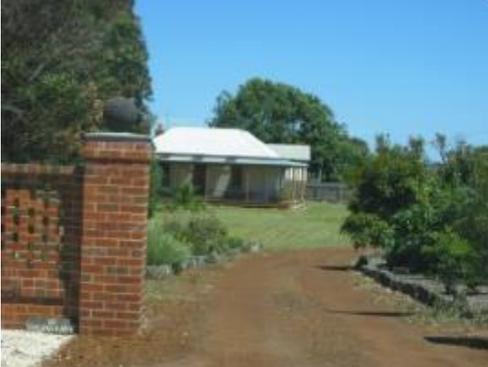
<p>(Photo: Rose Overberg 2015)</p>
Residence, 170-172 Browning Street	none	<p>Property also fronts onto Valmai Avenue. Victorian stone (?) cottage set back from street. Some alterations have been made. Further investigation required as not clearly visible from the street.</p> <p>Priority Ranking: 2</p>	Historical Aesthetic	Nominate for HO Prepare statement of significance

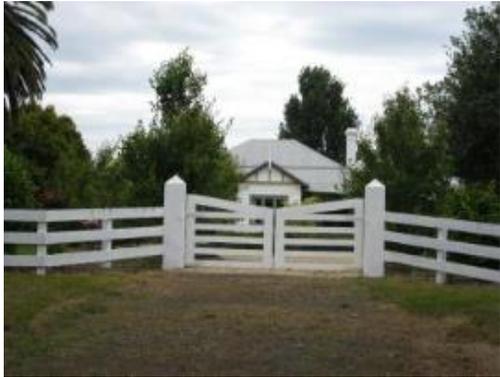
Item name and address	Current HO	Details	HERCON Assessment	Recommendations	Photographs
Residence, 41 Caledonian Hill Road	none	<p>Large Victorian timber house. Mature plantings including large palm tree.</p> <p>Further assessment including site visit required.</p> <p>Priority Ranking: 2</p>	<p>Historical Aesthetic</p>	<p>Possibly for HO</p>

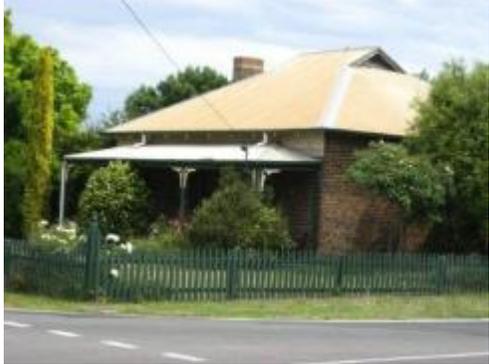
<p>(Photo: Rose Overberg 2015)</p>
Residence, 9 Parker Street	none	<p>Brick house, Portland brick. Define construction date. Good example of early brick cottage made from local materials.</p> <p>Priority Ranking: 1</p>	<p>Historical Representative Aesthetic Creative / Technical</p>	<p>Nominate for HO Prepare statement of significance</p>

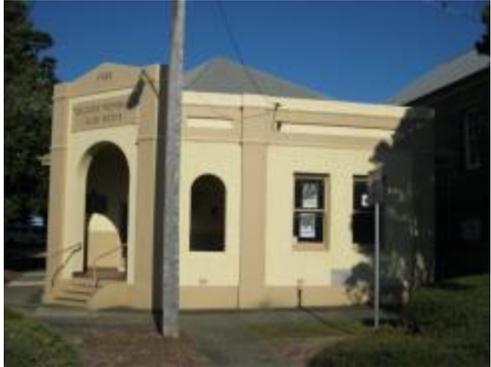
Item name and address	Current HO	Details	HERCON Assessment	Recommendations	Photographs
Soldiers Memorial Clubrooms, 23 Percy Street	Within HO165	1923. Brick with rendered front and sides. Good condition external.  Priority Ranking: 1	Historical Aesthetic Creative / Technical Associative (cultural)	Nominate for HO Prepare statement of significance

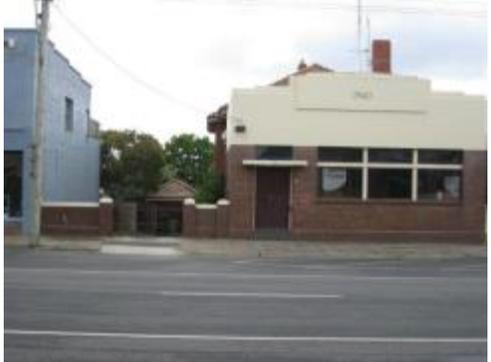
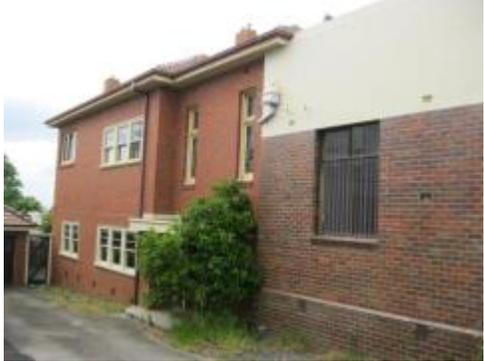
(Photo: Rose Overberg 2015)
Former State Savings Bank, 30 Percy Street	Within HO165	Former State Savings Bank (c1940), possibly built over 19 <sup>th</sup> C structure. Investigate further and research original buildings. Internal inspection required. Include historic pear trees at rear of this property.  Priority Ranking: 1	Historical Aesthetic Representative Creative / Technical Associative (cultural)	Nominate for HO Prepare statement of significance

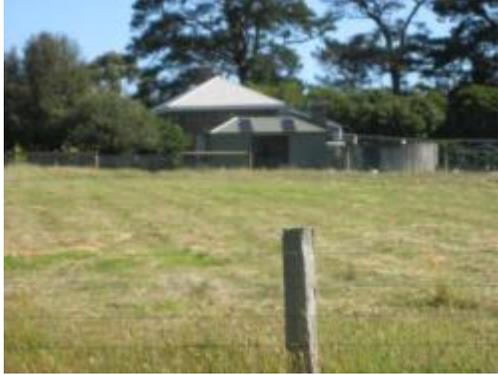
<p data-bbox="1594 751 1888 775">(Photos: Rose Overberg 2015)</p>
<p data-bbox="125 794 293 879">"Caxton" 481 Portland –Nelson Road</p>	<p data-bbox="331 794 387 818">None</p>	<p data-bbox="555 794 1048 951">c1850 single storey stone homestead. Mentioned in C78 Amendment. Viewed, photo taken, but access didn't permit detailed assessment. Portland-Nelson Road opposite Westlakes Road intersecton.</p> <p data-bbox="555 1002 734 1026">Priority Ranking: 1</p>	<p data-bbox="1084 794 1279 895">Historical Representative Creative / Technical</p>	<p data-bbox="1368 794 1547 887">Nominate for HO Prepare statement of significance</p>

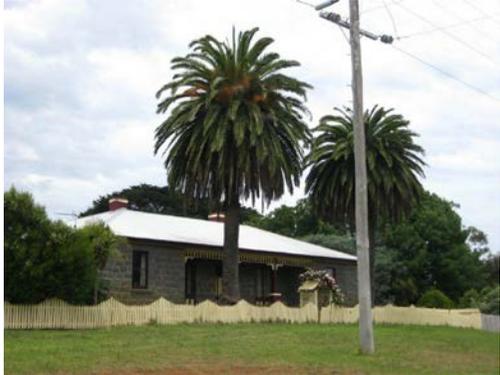
Item name and address	Current HO	Details	HERCON Assessment	Recommendations	Photographs
Residence, 126 Princes Highway	None	Large bluestone house with two mature palm trees  Priority Ranking: 1	Historical Aesthetic Creative / Technical	Nominate for HO Prepare statement of significance

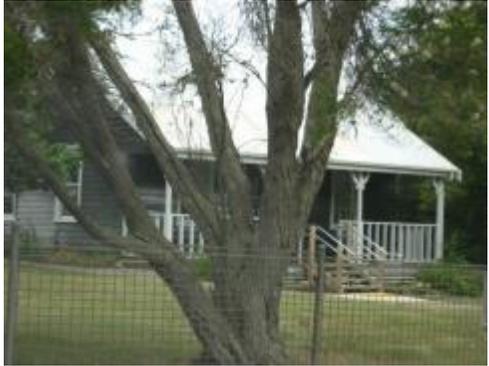
<p>(Photo credit: Google maps, 2010)</p>
Former Head Teachers House, School Road	None	Building c1870. HO to only include extent of Head Teachers residence and reasonable curtilage. Source a better photo.  Priority Ranking: 1	Historical Rarity Research Aesthetic Associative (Cultural)	Nominate for HO Prepare statement of significance

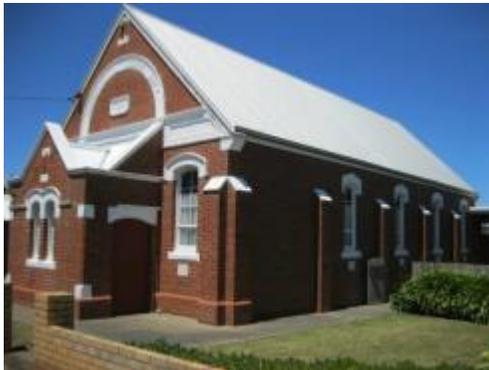
<p>(Photo: Rose Overberg 2015)</p>
Presbyterian School Hall, 15 Tyers Street	None	C1901. Red brick Federation style. Excellent external condition.  Priority Ranking: 1	Historical Aesthetic Associative (Cultural)	Nominate for HO Prepare statement of significance

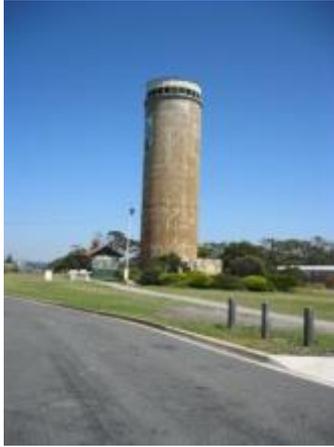
Item name and address	Current HO	Details	HERCON Assessment	Recommendations	Photographs
Water Tower, Wade Street	None	<p>Historic water tower. Research history and significance. Undertake detailed comparative analysis to determine significance. Refer to Conservation Management Plan for the tower</p> <p>The water tower was constructed in the 1930s due to developing water needs of the town. Prior to the water tower, water was supplied from wells, Fawthrop Lagoon and rainwater</p> <p>This water tower was used in the 1970s to 1980s. Historic Buildings Restoration Fund has more information.</p> <p>Priority Ranking: 1</p>	<p>Historical Representative Aesthetic</p>	<p>Nominate for HO Prepare statement of significance</p>

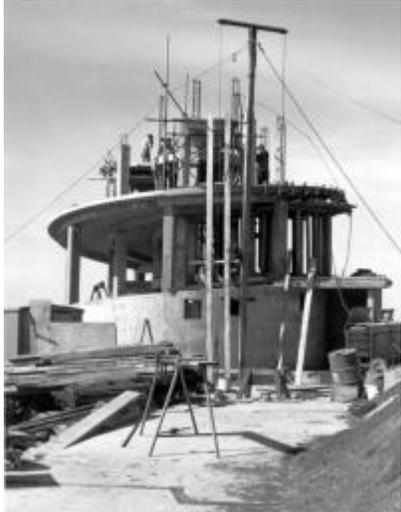
<p>(Photos: Rose Overberg 2015)</p>
<p>The Corkscrew, Portland Breakwater</p>	<p>None</p>	<p>Part sculpture, part public building, the Corkscrew was built as an icon for community with funds and materials left over from breakwater construction. Built during construction of the KS Anderson Wharf, c 1959.  <a href="http://glenelglibraries.vic.gov.au/historictreasures/stories/the-port-of-portland">http://glenelglibraries.vic.gov.au/historictreasures/stories/the-port-of-portland</a></p> <p>Priority Ranking: 1</p>	<p>Aesthetic Creative / Technical Associative (Cultural)</p>	<p>Nominate for HO Prepare statement of significance</p>

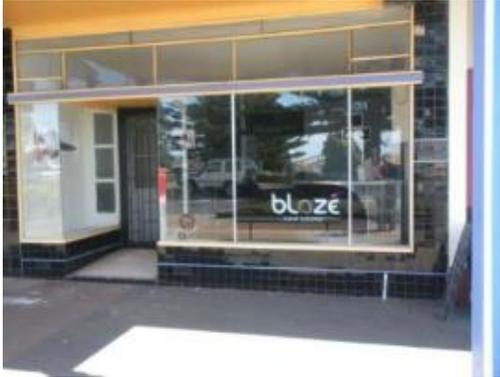
Item name and address	Current HO	Details	HERCON Assessment	Recommendation	Photographs
Shop, 47 Bentinck Street	Under HO165	<p>1940s-1950s. Interesting parapet and tiles on façade. Upper shop windows are interesting geometric design.</p> <p>Priority Ranking: 2</p>	Representative Aesthetic	Possibly for HO

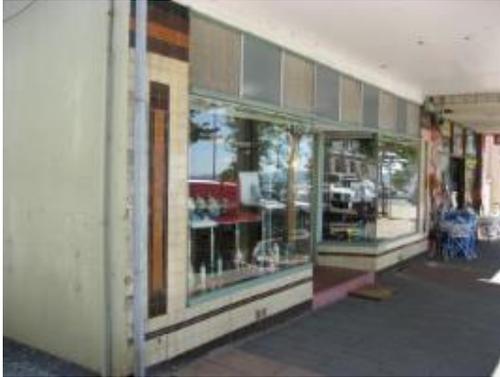
<p>(Photo credit: Dundas Real Estate)</p>
Shop, 59 Bentinck Street	Under HO165	<p>Good example of 1920s (?) tiles on façade. New upper façade (replica). Coloured glass on shop windows (Edwardian). Chimney at rear.</p> <p>Good representative example of Edwardian shop front.</p> <p>Further investigation and internal inspection would be required to determine if it meets criteria based on alterations.</p> <p>Priority Ranking: 2</p>	Representative Aesthetic	Possibly for HO

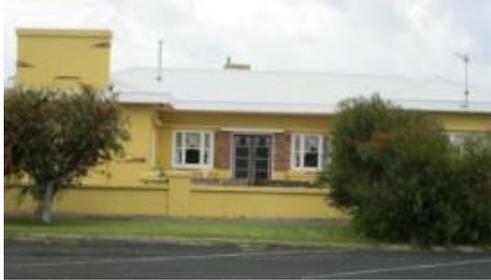
Item name and address	Current HO	Details	HERCON Assessment	Recommendation	Photographs
Residence, 33 Blair Street	none	<p>Art deco residential building. Great use of thin bricks (similar to Portland Primary School) as decorative elements. Good condition.</p> <p>Priority Ranking: 2</p>	<p>Historical Representative Aesthetic Creative/ Technical</p>	Possibly for HO

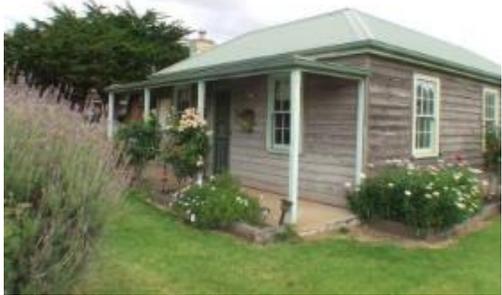
<p>(Photo: Rose Overberg 2015)</p>
Residence, 32 Burvilles Road	none	<p>Timber cottage, c1860(?). New external timber cladding (dark brown), original brick chimney. Was recently sold and has since been renovated. Representative of early timber cottages in Portland, however not sure how much original fabric remains.</p> <p>Priority Ranking: 3</p>	<p>Historical Representative</p>	Possibly for HO	<p>Approx 2013</p>

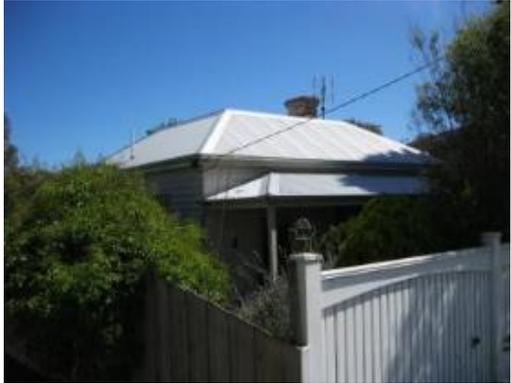
Item name and address	Current HO	Details	HERCON Assessment	Recommendation	Photographs
Residence, 21 Clarke Street	none	<p>Small timber house at front (onto Clarke Street) tongue and groove external boards on side elevation. Chimney of Portland brick. Extension at rear c1890s.</p> <p>High fence so photograph not possible. Statement of significance should mention association with brickworks on Clarke St. Owned by Henry Deacon (brick maker).</p> <p>Priority Ranking: 3</p>	<p>Historical Associative (Individual)</p>	Possibly for HO

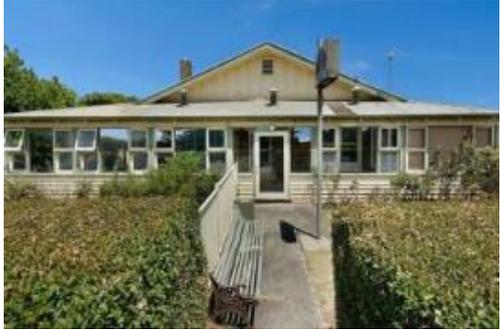
<p>(Photo: Rose Overberg 2015)</p>
Residence, 61 Cliff Street	Within HO165	<p>Large brick building in prominent Cliff street location. Functioned as a Guest House, then Mission to the Seafarers from 1962. Significant features include building layout, enclosed verandah, prominent location and cultural associations with the Port.</p> <p>Priority Ranking: 2</p>	<p>Historical Aesthetic Associative (Cultural)</p>	Possibly for HO

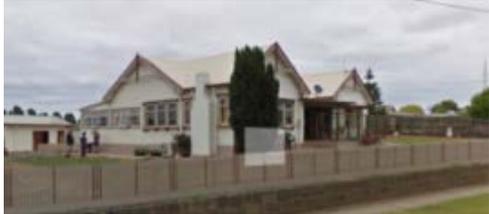
Residence, 65 Cliff Street	Within HO165	<p>Timber house c1890, including a very early section. Early section associated with immigration depot. Mirrored gable added in 20<sup>th</sup> C (possibly east side-hard to discern). Important building as designed under NSW Government (pre-separation).</p> <p>Priority Ranking: 3</p>	<p>Historical Aesthetic Associative (Cultural)</p>	Possibly for HO

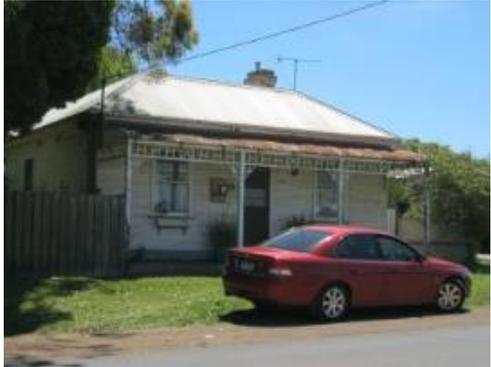
Item name and address	Current HO	Details	HERCON Assessment	Recommendation	Photographs
Residence, 41 Fitzgerald Street	none	<p>House, timber double-front, hand hewn weatherboards c1870s.</p> <p>One of a few timber cottages remaining in North Portland.</p> <p>Priority Ranking: 2</p>	<p>Historical Rarity Representative</p>	Possibly for HO

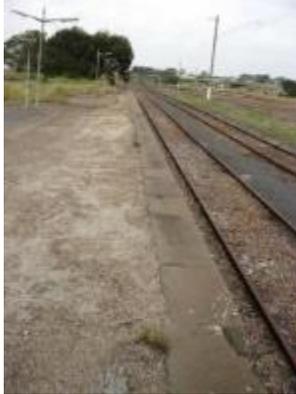
<p>(Photo: Rose Overberg 2015)</p>
Portland North Railway Station, off Francis Street	none	<p>Includes two original platforms (southern side is bluestone), lights. North side has orange brick station building c1968.</p> <p>Priority Ranking: 2</p>	<p>Historical Representative Associative (cultural)</p>	Possibly for HO

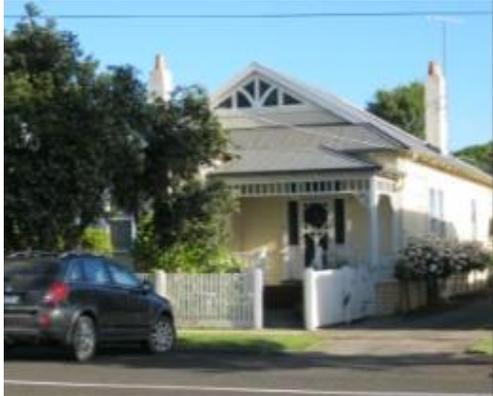
Item name and address	Current HO	Details	HERCON Assessment	Recommendation	Photographs
Residence, 48 Gawler Street	Within HO165	<p>House, timber and rough cast. Edwardian/Federation Arts and Crafts. Stained glass.</p> <p>Priority Ranking: 2</p>	Representative Aesthetic	Possibly for HO

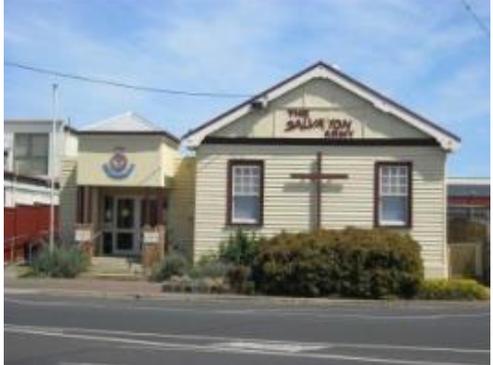
<p>(Photo: Rose Overberg 2015)</p>
Salvation Army Citadel., 33 Henty Street	Within HO165	<p>Some alterations to front on left side. Detracts from building. There may be heritage value in remnant fabric, function and associations. Needs further assessment including internal inspection to assess.</p> <p>Priority Ranking: 2</p>	Historical Representative Associative (cultural)	Possibly for HO

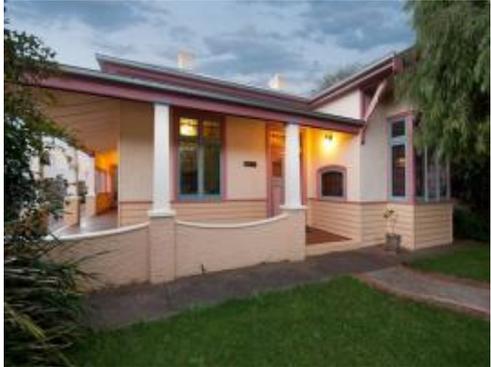
Item name and address	Current HO	Details	HERCON Assessment	Recommendation	Photographs
Residence, 62 Julia Street	Within HO165	<p>Federation (?) brick house with large ornate stained glass windows and rough-cast finished verandah on two sides.</p> <p>Further research to find out about associations and heritage significance</p> <p>Priority Ranking: 2</p>	<p>Aesthetic Creative / technical</p>	Possibly for HO

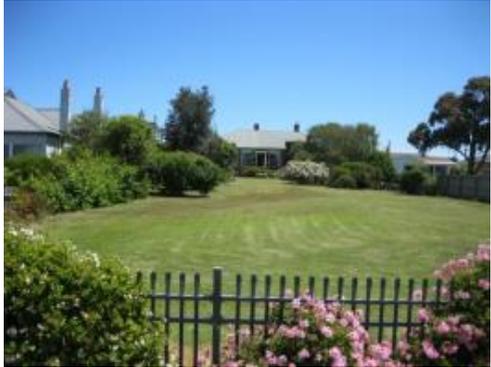
<p>(Photo credit: realesate.com.au, 2011)</p>
Residence, 13 Market Court	none	<p>House and garage, Portland Brick, large house, faces the sea (east), offset frontage to Bentinck Street.</p> <p>Some alterations to windows on east side.</p> <p>Research owner, builder and significance.</p> <p>Priority Ranking: 3</p>	<p>Aesthetic Creative / technical Associative (?)</p>	Possibly for HO

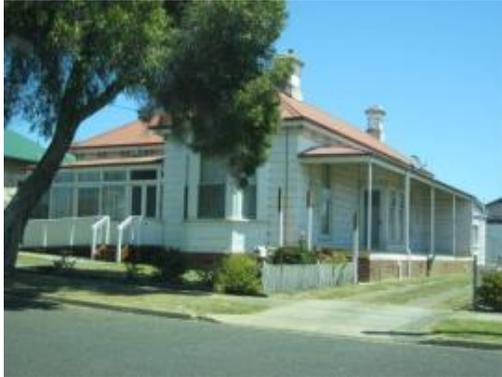
Item name and address	Current HO	Details	HERCON Assessment	Recommendation	Photographs
Residence, 5 Market Court	none	House, timber, blocked front, late Victorian. Large. C1890.  Priority Ranking: 3	Research Representative Aesthetic	Possibly for HO

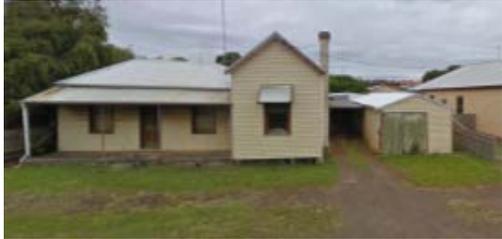
<p data-bbox="1594 767 1877 794">(Photo: Rose Overberg 2015)</p>
Residence, 102 Palmer Street	none	Timber house c1850-1870s. Double front, gable end on right side is not original (but probably dates to Victorian times).  Priority Ranking: 2	Historical Rarity Representative	Possibly for HO

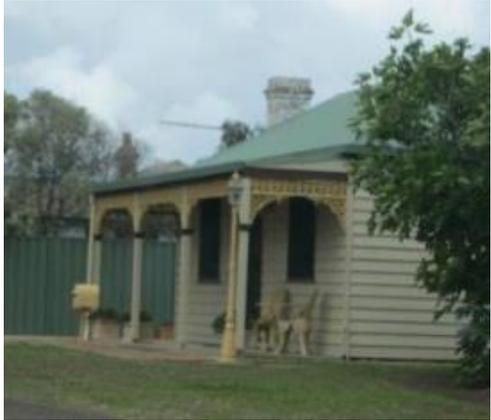
Item name and address	Current HO	Details	HERCON Assessment	Recommendation	Photographs
3 Pattersons Lane	None	<p>Simple timber cottage. Has been restored. Mentioned in 1981 PUC Study( page 98). Contact VHI for full file.</p> <p>Priority Ranking: 2</p>	Historical	Possibly for HO

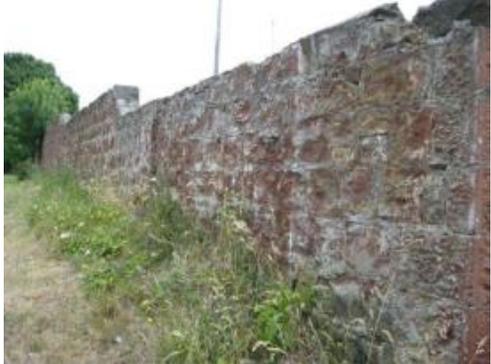
<p>(Photo: Rose Overberg 2015)</p>
Bluestone wall, behind 37 Percy Street	Within HO165	<p>Behind Portland Club. Check against titles to confirm which property it is on. Confirm location.</p> <p>Priority Ranking: 2</p>	Historical Aesthetic	Possibly for HO	None available

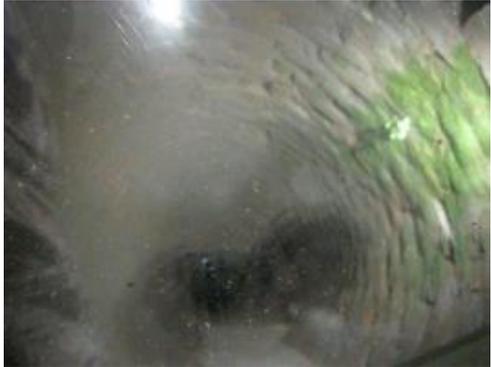
Item name and address	Current HO	Details	HERCON Assessment	Recommendation	Photographs
Shops, 53A Percy	Within HO165	<p>Large commercial brick building divided into 3 shops. C1880s. Original parapet in place but covered. Bricks are Portland Brick.</p> <p>3/53 Percy has well which has been covered with glass so is visible in shop.</p> <p>Priority Ranking: 2</p>	Historical	Possibly for HO

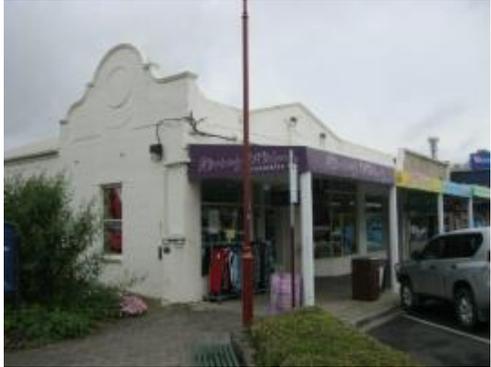
<p>(Photo: Rose Overberg 2015)</p>
Shop, 63 Percy Street	Within HO165	<p>Research and assess significance of shop front (Dutch gable style), Interesting detail from side view. Not assessed in Portland Urban Conservation Study 1981.</p> <p>Priority Ranking: 2</p>	Historical Rarity Aesthetic	Possibly for HO

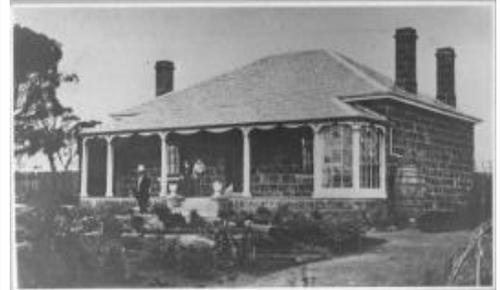
Item name and address	Current HO	Details	HERCON Assessment	Recommendation	Photographs
<b>Buildings</b>					
61 Bancroft Street	HO90	The Corney House. 1856 House built for prisoner grazier, William Corney. Significance assessment needs updating. Trees in front and rear gardens should be mentioned.	Historical Rarity Research Aesthetic Associative (Individual)	Retain on HO Revise significance assessment

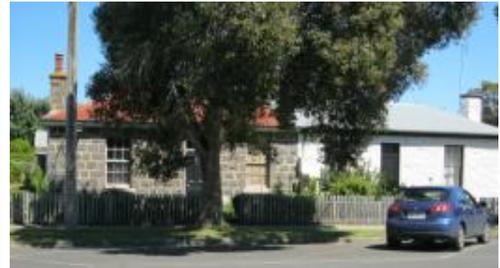
9-11 Bentinck Street	HO9	Significance assessment needs updating. Buildings at rear of 9, chimneys and other important elements to be mentioned.	Historical Research Representative Aesthetic	Retain on HO Revise significance assessment

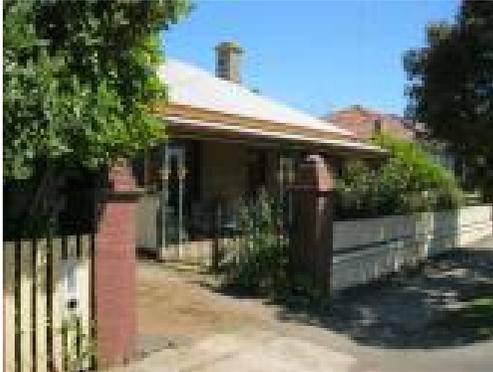
Item name and address	Current HO	Details	HERCON Assessment	Recommendation	Photographs
19 Bentinck Street	HO10	Significance assessment needs updating. Should mention the elements about this place that are important, regular coursed basalt, fence, tiled verandah, stone outbuildings. Intact and well maintained.	Research Representative Aesthetic	Retain on HO Revise significance assessment

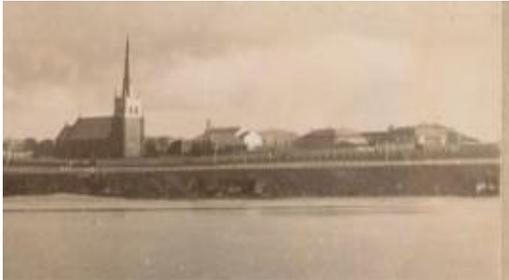
<p>(Photo Rose Overberg 2015)</p>
All Saints Catholic Church, 115 Bentinck Street	HO81	Ensure significance assessment mentions former location of Mary MacKillop's Chapel, old bluestone cottage inside the Manse and the substantial fence along Bentinck Street.	Historical Research Representative Aesthetic Associative (cultural)	Retain on HO Revise significance assessment	<p>1886</p>

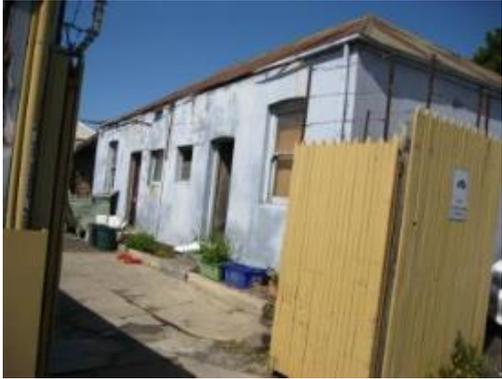
Item name and address	Current HO	Details	HERCON Assessment	Recommendation	Photographs
Richmond Henty Hotel Complex	HO114	<p>Ensure that significance assessment includes mention of important items – remnant walls, small stone cottage and symbolism of the site.</p> <p>This complex is mapped on Birmingham's 1853 Map. Map and record all heritage features at the site.</p>	<p>Historical Research Representative Aesthetic Associative (cultural)</p>	<p>Retain on HO Revise significance assessment Individual items of importance need to be identified</p>

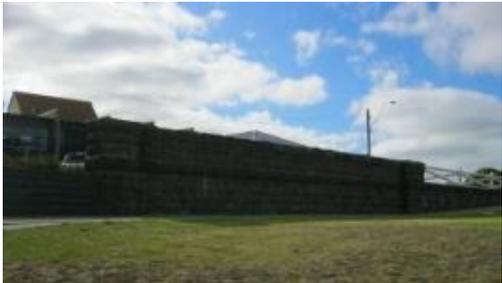
<p>(Photo: Rose Overberg 2015)</p>
Railway Bridge and cutting	HO123	<p>This is significant as one of the last remaining places associated with the Portland railway.</p> <p>HO mapped location does not match actual location of item.</p>	<p>Historical Research Rarity Representative Aesthetic</p>	<p>Retain on HO Revise significance assessment Revise HO map</p>
