# Portland Heritage Gaps Study

Glenelg Shire Council

Review and Recommendations Report

IS123700\_002 | V3

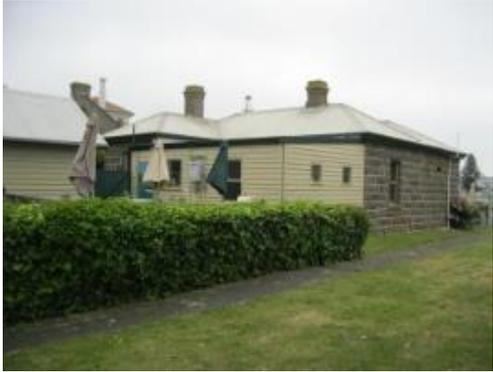
Item name and address	Current HO	Details	HERCON Assessment	Recommendation	Photographs
Former Watch House, 85 Cliff Street	HO37	The Watch House was originally one room on each side, then extended back and became Keepers house. Around 1934 became Police residence and partitions and internal walls added. This is one of a few pre-Separation buildings therefore highly significant. Stone at front and timber at rear. Statement of significance needs to be revised to ensure that important fabric is identified.	Historical Research Representative Aesthetic Associative (Individual) Associative (cultural)	Retain on HO Revise significance assessment

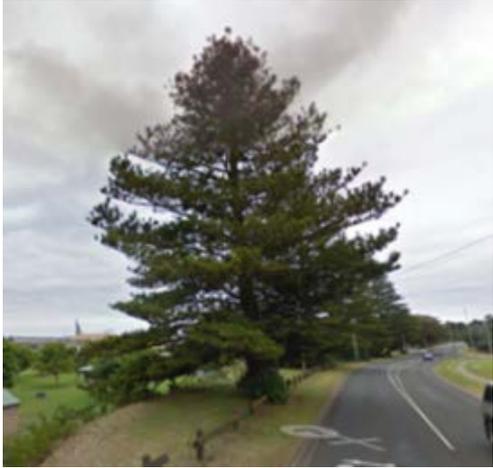
<p>(Photo: Rose Overberg 2015)</p>
Araucaria araucana (Salisb.) France, Norfolk Island Pine (14 in No.)	HO128	14 Norfolk Island Pines along Cliff Street. Individual locations should be mapped. Statement of significance should be revised.	Historical Aesthetic Associative (cultural)	Retain on HO Revise significance assessment Revise HO map

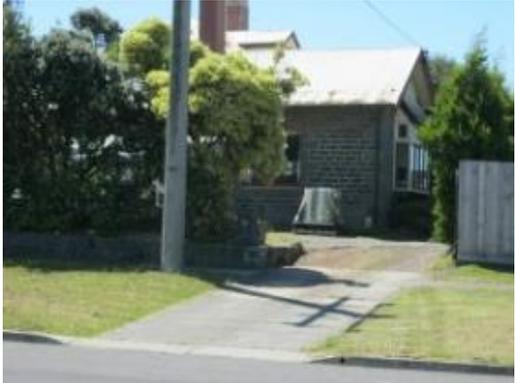
Item name and address	Current HO	Details	HERCON Assessment	Recommendation	Photographs
Residence, 16 Fern Street	HO107	House (Portland Brick) built for retired clergy. Located on a hill facing the sea. First cemetery located on or adjacent to property. Needs further research into history and significance of the house and the possible cemetery location.	Historical Research Aesthetic Associative (cultural)	Retain on HO Revise significance assessment

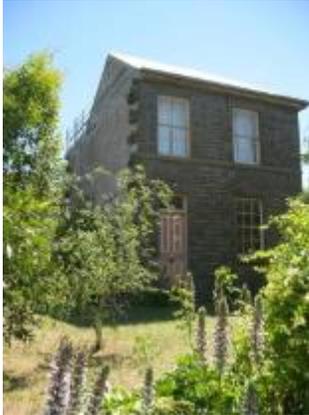
<p data-bbox="1592 778 1872 802">(Photo: Rose Overberg 2015)</p>
Former Hills School, 33-35 Fitzgerald Street	HO100	Double storey bluestone building. Reasonable condition. At risk of development. Further research required for history and ownership of property.	Historical Research Aesthetic Associative (cultural)	Retain on HO Revise significance assessment

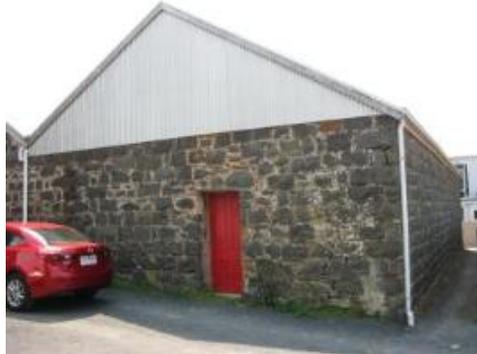
Item name and address	Current HO	Details	HERCON Assessment	Recommendation	Photographs
Bluestone store, rear of 3 and 5 Julia Street	Part HO68 and HO69, and part HO165	Bluestone store at rear (c1850s). Need to revise HO for these properties to ensure this building has HO protection.	Historical Research Aesthetic	Revise HO. Prepare statement of significance

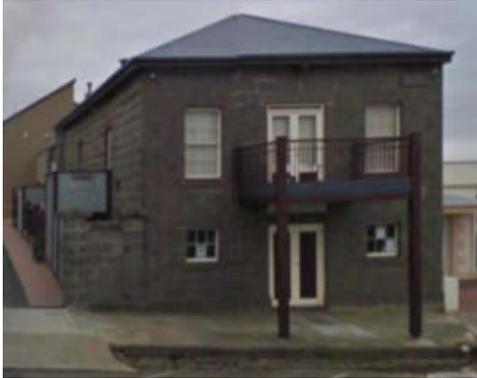
<p data-bbox="1592 751 1877 775">(Photo: Rose Overberg 2015)</p>
Former Henty Wool store, 6 Julia Street	HO65	Former Henty Wool store. Significance assessment needs more detail	Historical Research Representative Aesthetic	Retain on HO Revise significance assessment

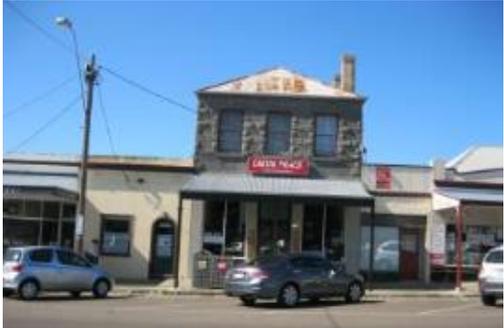
Item name and address	Current HO	Details	HERCON Assessment	Recommendation	Photographs
Shops, 5A, 7 and 7A Julia Street	HO69	<p>Revise significance assessment to include mention and discussion for each of the three buildings (different in character and form). Obtain file from National Trust to inform this.</p> <p>Number 7A is a later laneway "in-fill" building.</p>	<p>Historical Research Aesthetic</p>	<p>Retain on HO Revise significance assessment</p>

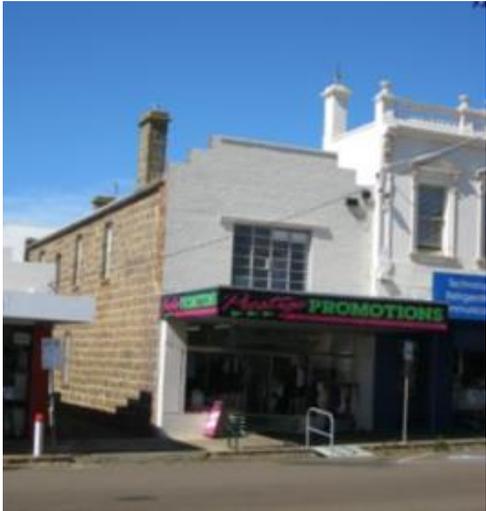
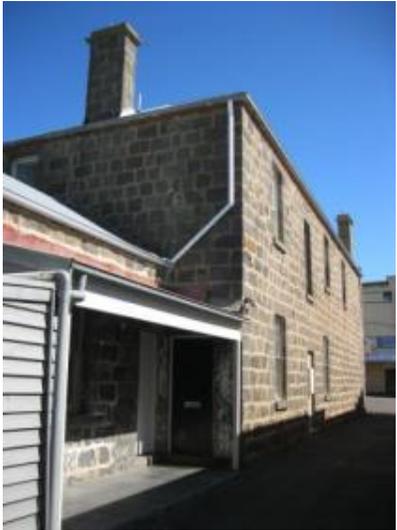
Item name and address	Current HO	Details	HERCON Assessment	Recommendation	Photographs
Shop, 35-37 Julia Street	HO76	Intact two storey bluestone building. Except for façade (c1950s). From side photos you can see how newer brick parapet has been tied in to bluestone building. Original doors on residence at rear.	Historical Aesthetic	Retain on HO Revise significance assessment

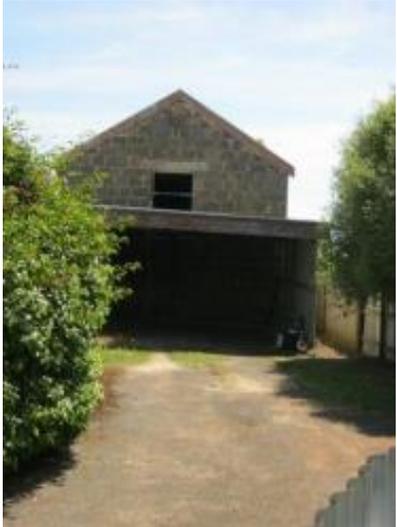
Item name and address	Current HO	Details	HERCON Assessment	Recommendation	Photographs
Claremont, 65 Julia Street	HO26	Revise significance assessment to include mention of stone barn at rear (in original condition). Possibly at risk of development from caravan park.	Historical Rarity Research Aesthetic Associative (Individual)	Retain on HO Revise significance assessment

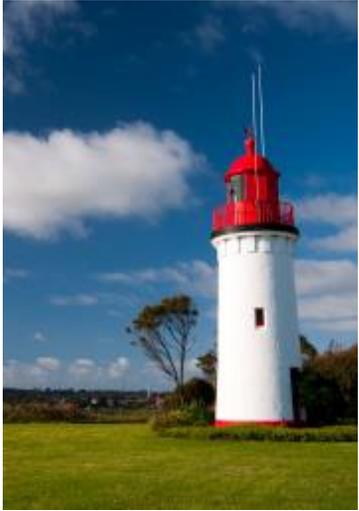
Item name and address	Current HO	Details	HERCON Assessment	Recommendation	Photographs
Whalers Bluff Lighthouse, Lighthouse Avenue	HO96	Current statement of significance has insufficient detail. Refer to National Trust file for detail.	Historical Research Representative Creative / technical Associative (cultural)	Retain on HO Revise significance assessment

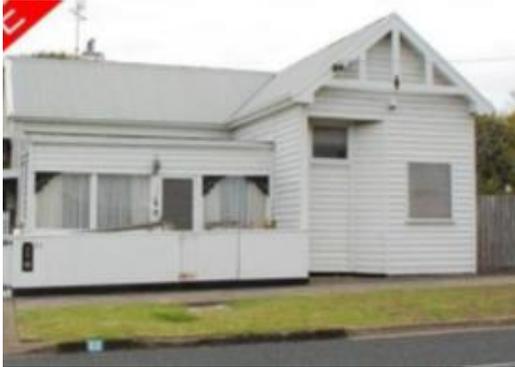
Item name and address	Current HO	Details	HERCON Assessment	Recommendation	Photographs
Residence, 22 Otway Street	HO106	Small timber commercial / residential cottage c1900s.	Aesthetic Creative / Technical	Retain on HO Revise significance assessment

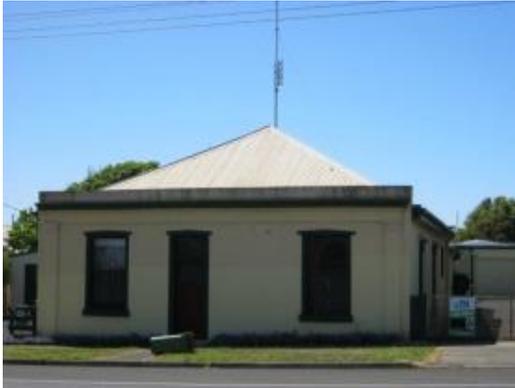
<p>(Photo credit: Dundas Coastal real estate)</p>
Residence, 32 Otway Street	HO103	Brick and stone house with rendered front with entablature and doric pilasters. Reasonable condition external. c1880. Significance assessment needs to be more detailed.	Aesthetic Creative / Technical	Retain on HO Revise significance assessment

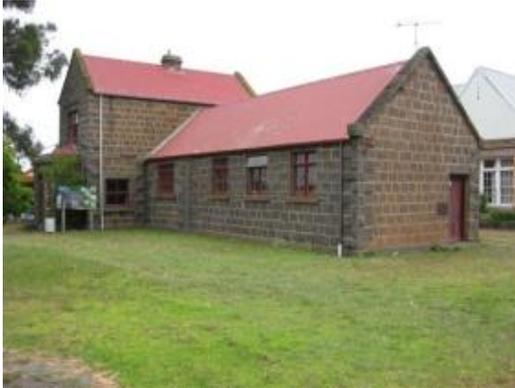
Item name and address	Current HO	Details	HERCON Assessment	Recommendation	Photographs
Former National School, 45 Palmer Street	HO54	<p>The description for HO54 (on Victorian Heritage Database) is incorrect as it describes the Former National School at Cape Bridgewater.</p> <p>Detailed statement of significance on the VHR (listing H1627) should be used as a base to develop local statement of significance.</p>	<p>Historical Aesthetic Creative / technical Associative (Cultural)</p>	<p>Retain on HO Revise significance assessment Corrections to HERMES / VHD</p>

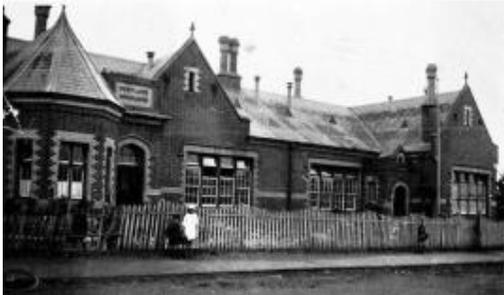
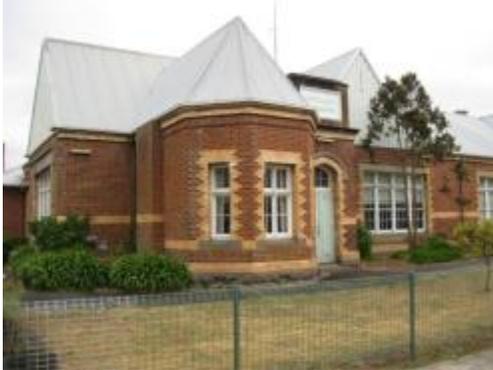
Item name and address	Current HO	Details	HERCON Assessment	Recommendation	Photographs
Portland School 489	HO56	<p>Revise significance assessment, mention important elements within grounds.</p> <p>Major parts of building (gables, slate roof and tower have been removed).</p>	<p>Historical Creative / technical Associative (Cultural)</p>	<p>Retain on HO Revise significance assessment</p>	<p>1925</p>

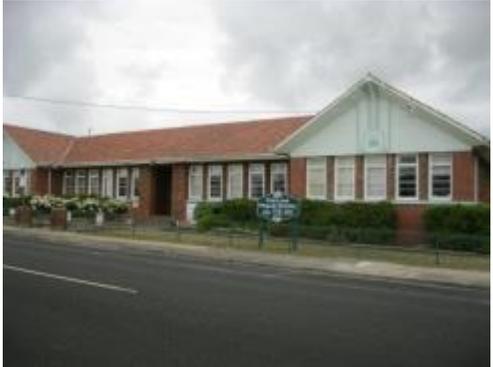
Item name and address	Current HO	Details	HERCON Assessment	Recommendation	Photographs
Portland Primary School	HO56	C1940s Art Deco. Revise significance assessment to document architectural significance and history of the building.	Historical Aesthetic Creative / technical Associative (Cultural)	Retain on HO Revise significance assessment

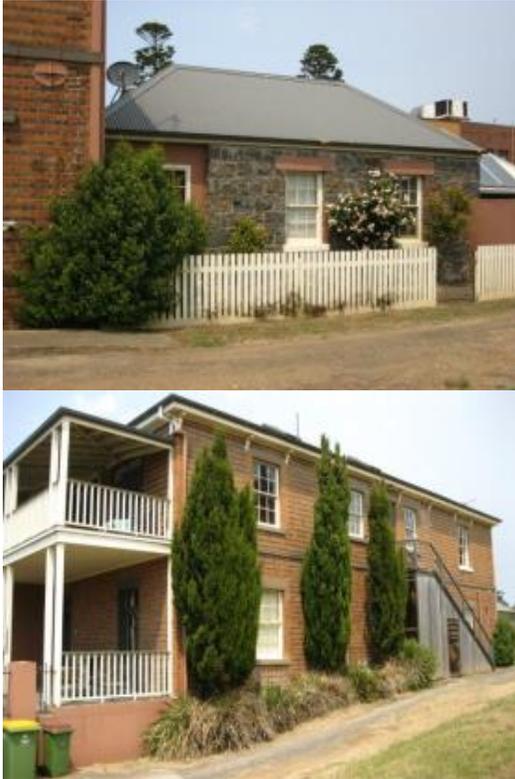
Item name and address	Current HO	Details	HERCON Assessment	Recommendation	Photographs
Brick Store, 27 A Percy Street	HO19	Update significance assessment to include reference to bluestone cottage joined to rear of brick store. New verandah and windows at front of Brick Store. Original windows at rear.	Historical Rarity Aesthetic Creative / technical	Retain on HO Revise significance assessment

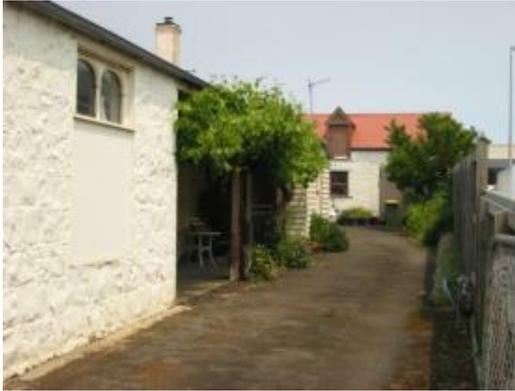
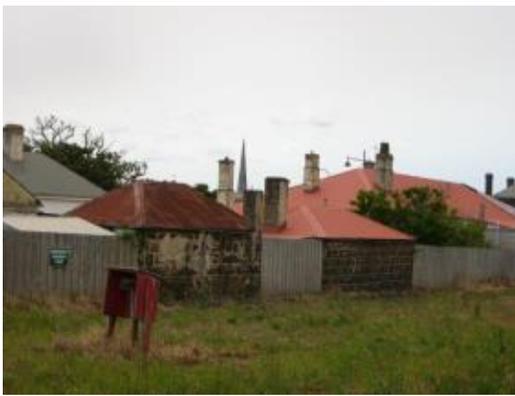
Item name and address	Current HO	Details	HERCON Assessment	Recommendation	Photographs
Campbell's Drapery including outbuildings, well, pump etc, 57 Percy Street	HO59	Site inspection confirms items are present. Well still on site. Revise significance assessment to ensure all items are mentioned (stables, outbuildings, well, pump, windows on bluestone, mature fruit trees, out kitchen etc)	Historical Rarity Research Aesthetic Creative / technical	Retain on HO Revise significance assessment Merge HO59 and HO60

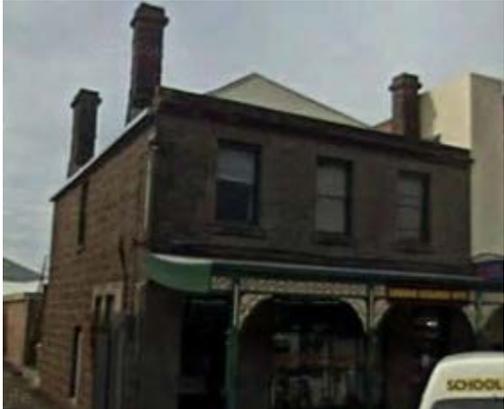
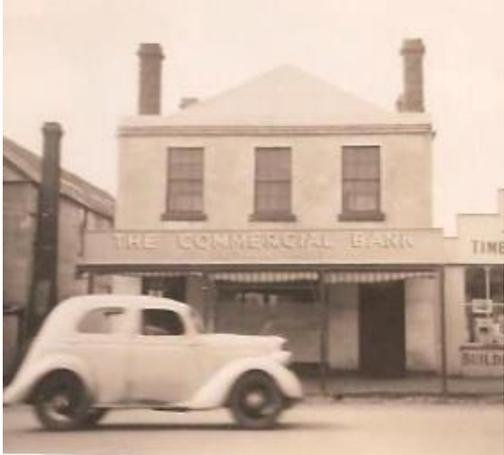
Item name and address	Current HO	Details	HERCON Assessment	Recommendation	Photographs
Shop, 58-60 Percy Street	HO33	Bluestone two storey shop. Former Commercial Bank. Request file from National Trust. Revise significance assessment to fully assess this place.	Historical Research Aesthetic Creative / technical	Retain on HO Revise significance assessment

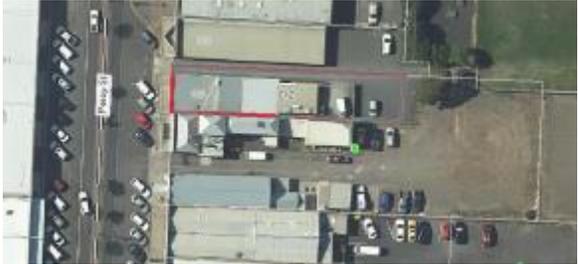
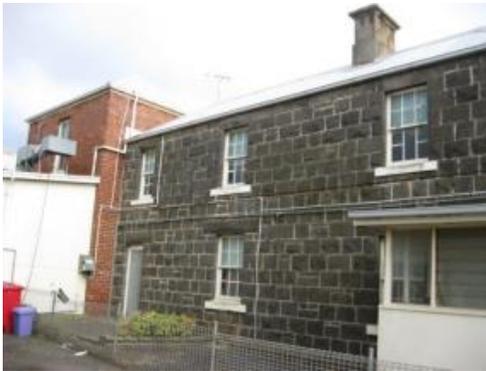
Item name and address	Current HO	Details	HERCON Assessment	Recommendation	Photographs
Shops, 98 Percy Street	HO111	Significance assessment should be updated to reflect different elements to protect in each place.	Historical Research Aesthetic Creative / technical	Retain on HO Revise significance assessment

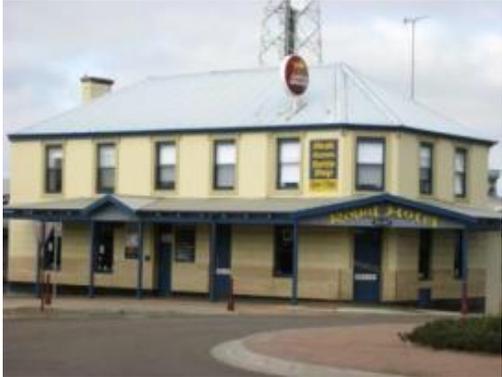
Item name and address	Current HO	Details	HERCON Assessment	Recommendation	Photographs
Royal Hotel , 113-119 Percy Street	HO86	Originally the Lamb Inn. Significance assessment should be updated	Historical Research Aesthetic Creative / technical Associative (Cultural)	Retain on HO Revise significance assessment

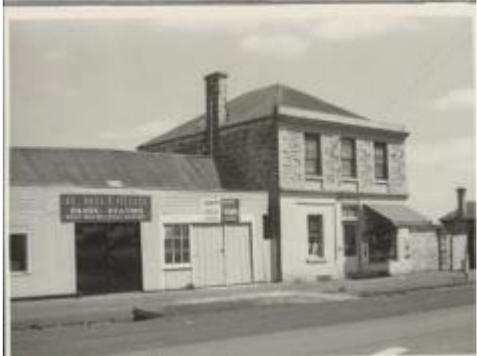
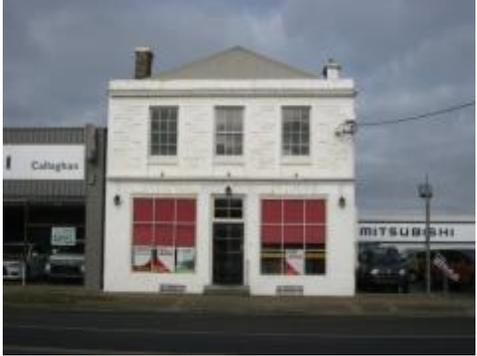
Item name and address	Current HO	Details	HERCON Assessment	Recommendation	Photographs
Building, 137 Percy Street	HO105	Two storey commercial bluestone building c1860. "Federal House" - get file from National Trust for more detail. Very good quality stone work. Investigate builder and architect.	Historical Research Aesthetic Creative / technical	Retain on HO Revise significance assessment

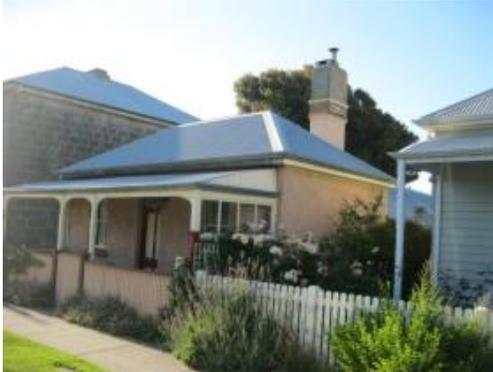
Item name and address	Current HO	Details	HERCON Assessment	Recommendation	Photographs
Residence, 9 Tyers Street	HO84	Considerable work has been done on restoring the house with original details. Excellent example of Conservation Management in local heritage. Statement of significance should be updated to include mention of significant internal features and fabric (see CMP)..	Historical Rarity Research Aesthetic	Retain on HO Revise significance assessment

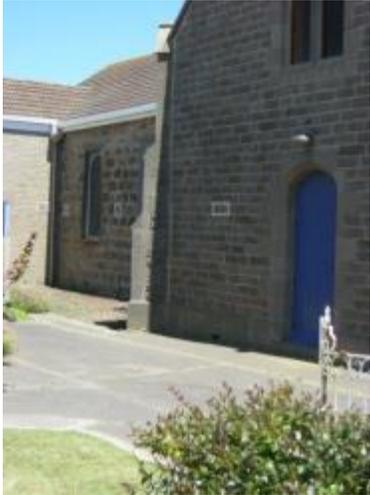
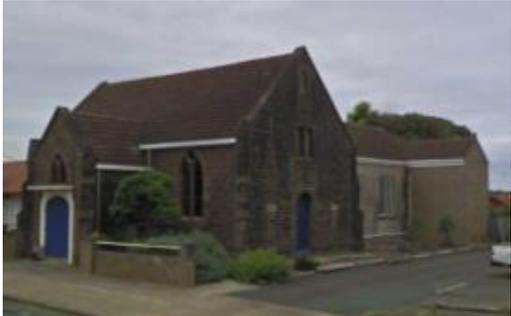
Item name and address	Current HO	Details	HERCON Assessment	Recommendation	Photographs
Uniting Church, Former Presbyterian Church	HO85	Oldest stone church in Portland (1849) should have a detailed Statement of significance. National Trust file has more detail.	Historical Research Aesthetic Creative / technical Associative (Cultural)	Retain on HO Revise significance assessment
